## Appendix B Ice Jam Mitigation Case Studies

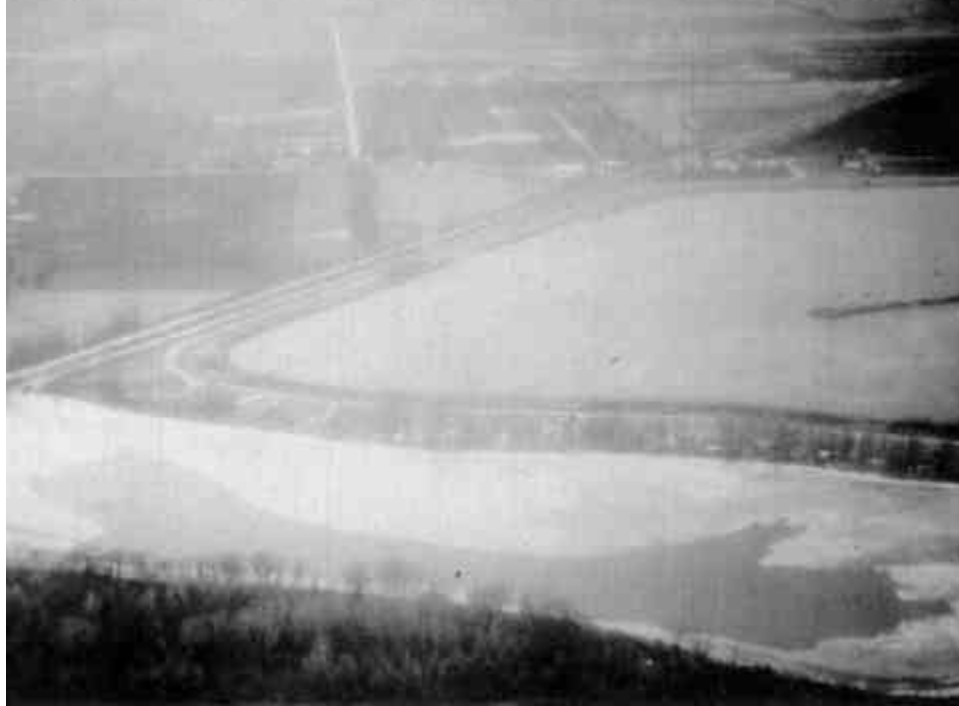
Figure B-2. Map of meltout, Kankakee River, Illinois

*b.* In a demonstration project, 20°C (68°F) water from the cooling ponds adjacent to the Kankakee River near Wilmington was siphoned in three 0.76-m-diameter (30-inch-diameter) pipes into the river upstream of the ice cover for 2 weeks prior to the anticipated breakup in 1988 (Figure B-1). The maximum siphon flow is 4.25 m<sup>3</sup>/s (150 ft<sup>3</sup>/s) compared with the expected river flow of approximately 113 m<sup>3</sup>/s (4000 ft<sup>3</sup>/s). The measured rise in water temperature was less than 0.56°C (1°F). The warm water input melted the existing ice so that ice floes passed unhindered during the natural breakup period and flooding was averted (Figure B-2).

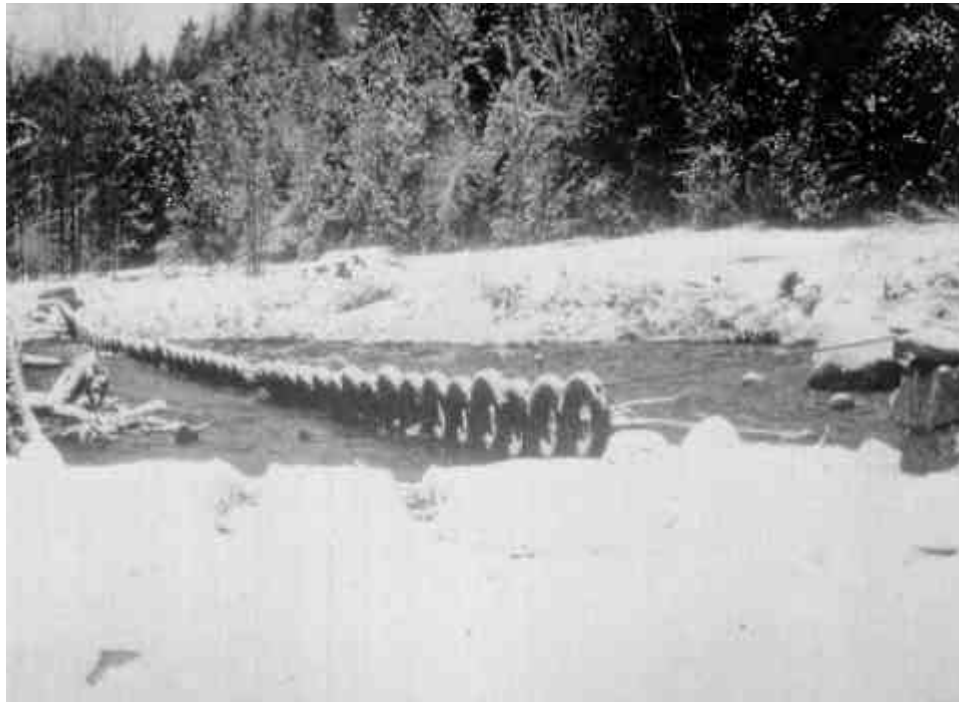
Figure B-3. Tire boom at Hardwick, Vermont

*b.* To slow the movement of broken ice, two booms were constructed (Figure B-3). The vertically oriented tire booms, which are suspended from shore, collect broken ice during breakup, some of which is stored on the overbanks. The booms delay the downstream passage of ice while ice removal is performed in town. Since the winter of 1983–84, these booms have been placed upstream from town annually. Although the booms occasionally fail, they do provide ice retention.

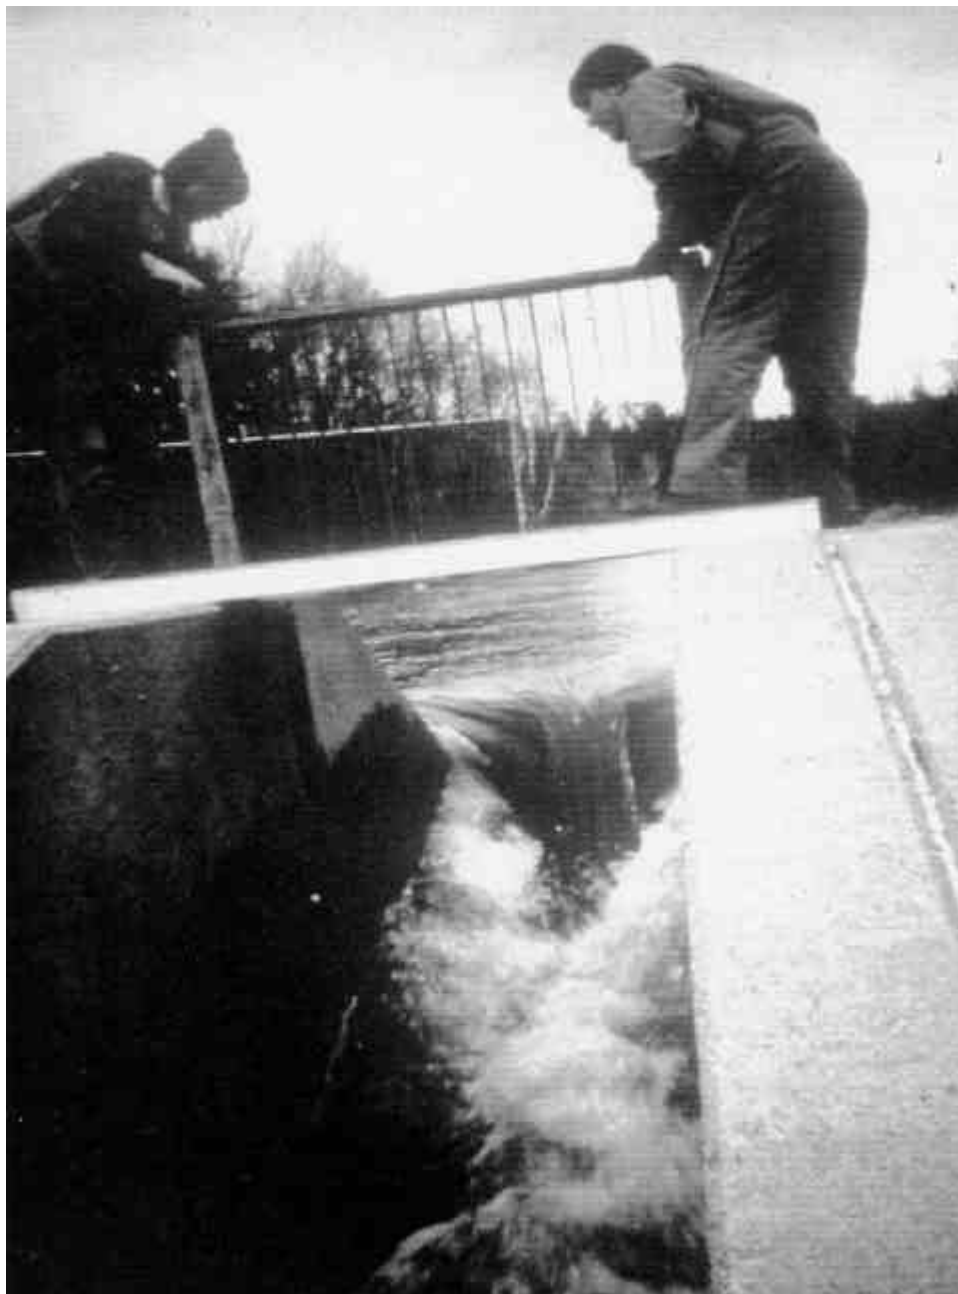
a. Installing racks in sluiceways

Figure B-5. Lancaster, New Hampshire, weir

*c.* The ice control weir includes four 1.2-meter-wide by 2.4-meter-deep (4-foot-wide by 8-foot-deep) sluiceways for fish passage. During the winter, stop logs or metal bar racks are placed in the sluiceways to develop an ice retention pool. The pool forms an ice cover, and frazil ice generated upstream deposits beneath the ice cover. After the ice cover has formed, two of the gates are opened, allowing the pool level to drop. This creates additional water storage in the pool area, provides additional discharge capacity through the weir, and slightly delays the breakup and movement of ice through the pool as well. The project, which cost \$300,000 was completed in 1982. Although costs constrained the size of the project to less than ideal, no major flooding has occurred since this relatively inexpensive, innovative project was constructed (Axelson 1991).

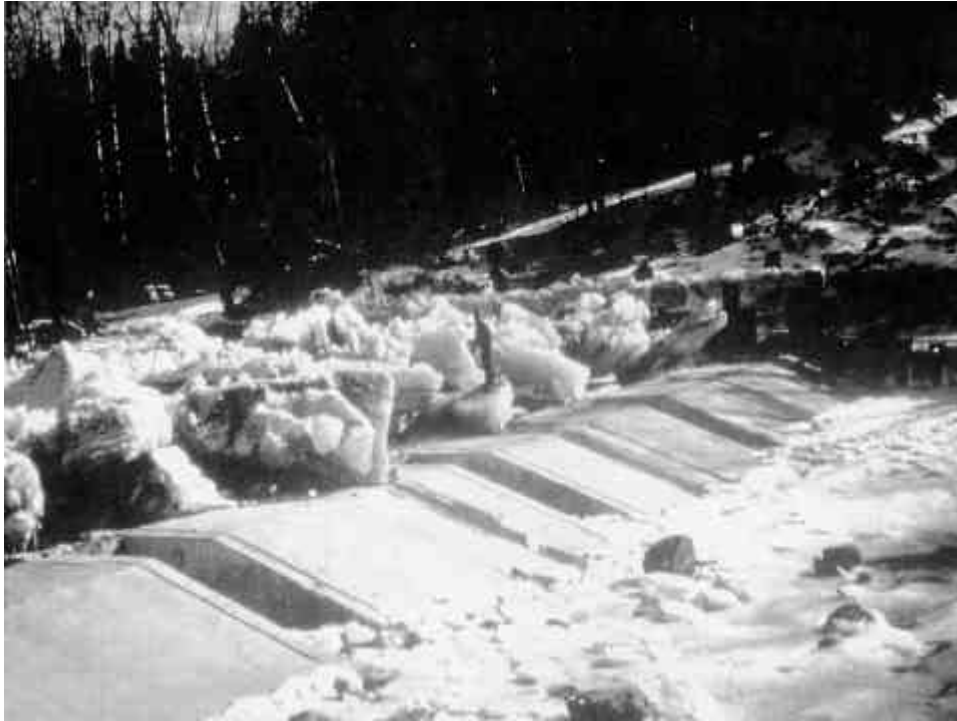
**b. Ice accumulated behind structure in early spring**

**Figure B-5. (Concluded)**
